Recreational Use Attainability Analysis for Buffalo Creek (0214B), Paradise Creek (0230A), and Sweetwater Creek (0299A) in the Red River Basin

DRAFT for PUBLIC REVIEW

Prepared for:
Texas State Soil and Water Conservation Board
Project 12-52

TR 1308

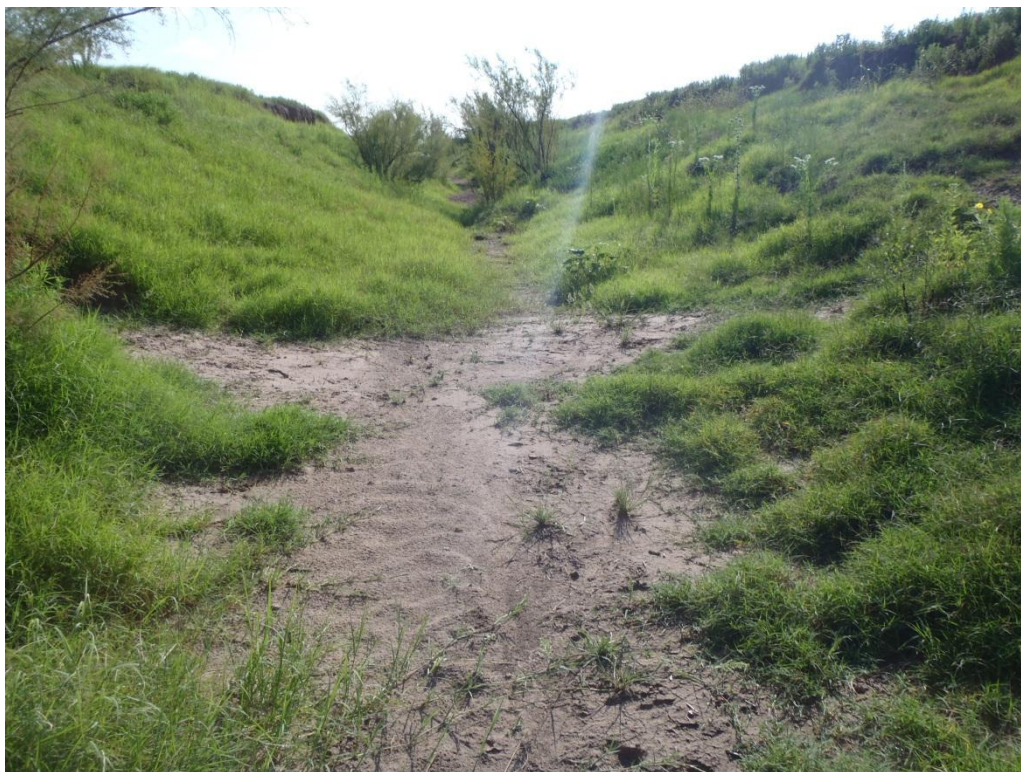
This segment of Paradise Creek was dry with an average thalweg of 0.00 m during both surveys (Tables 4.6, 4.7 and 4.8). No water was observed or measured at this site. The primary substrate was clay/mud under the bridge where water was standing during the first survey (Table 4.5). The corridor was dominated by improved pasture; however, some brush existed in the stream bed (Figure 4.54).

Figure 4.54 Photograph of PD020 taken August 13, 2013. Downstream view at the 300-m transect. Note lack of water, gentle slopes with improved grass and some shrubs.

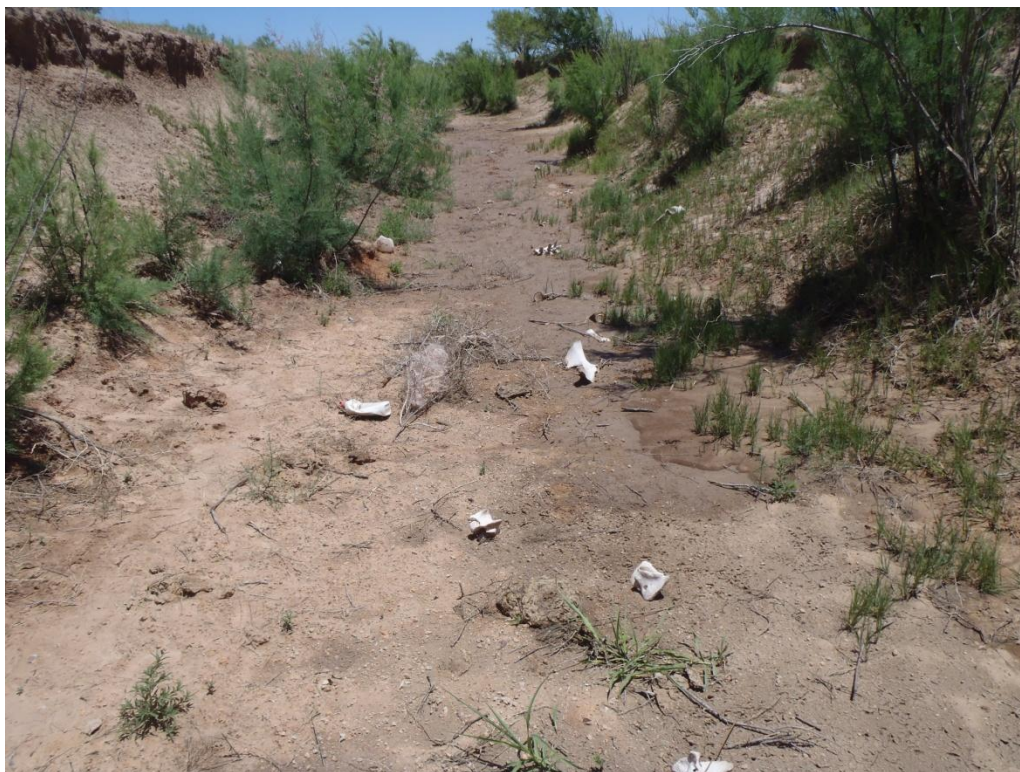
This site was surveyed on June 10 and August 13, 2013. Access to this site was on private property and permission from the landowner was granted to access the property through an electric fence to enter the stream (Table 4.6). Travel down to the site involved driving along the neighbors' fence line along the edge of a cultivated field. The channel was deep, however the banks were grassy and gently sloping with frequent livestock trails leading into the creek (Figure 4.55). All other travel through the creek at this site was easy and no obstacles were encountered.

Figure 4.55 Photograph of PD021 taken on June 10, 2013. Downstream view of the 150-m transect. Note the sloping banks, brush along stream and scattered cow bones.

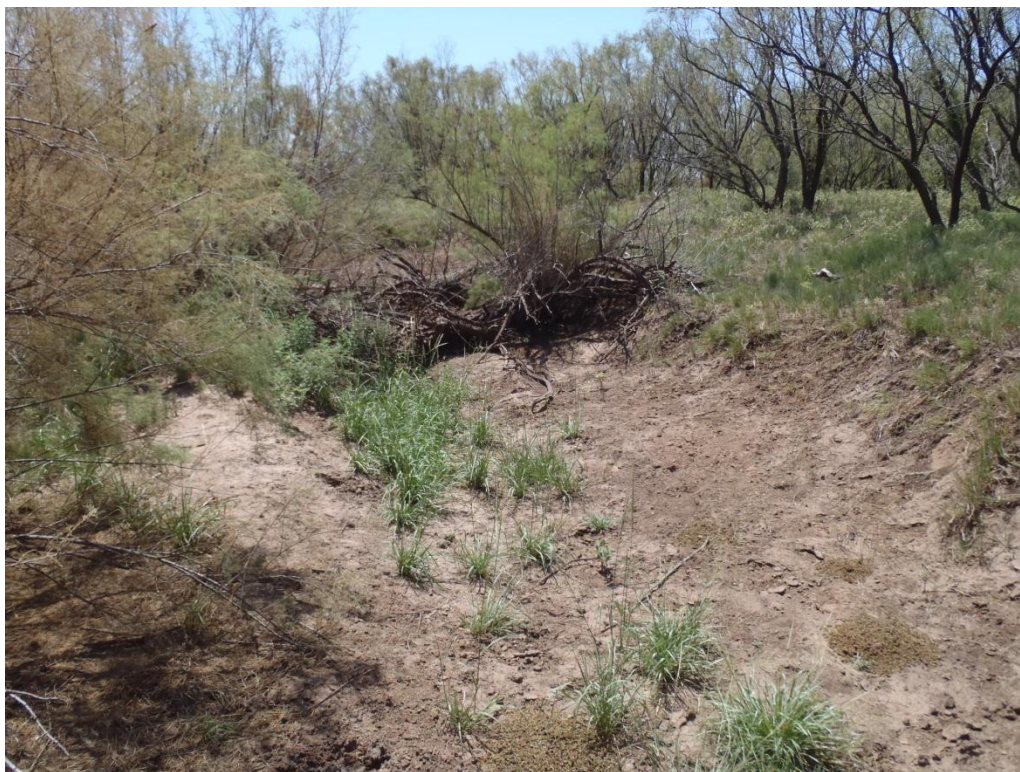
Figure 4.57 Photograph of PD022 taken August 12, 2013. Upstream view of the 300-m transect. Note lack of water, log obstruction, shrub and grass dominated corridor.

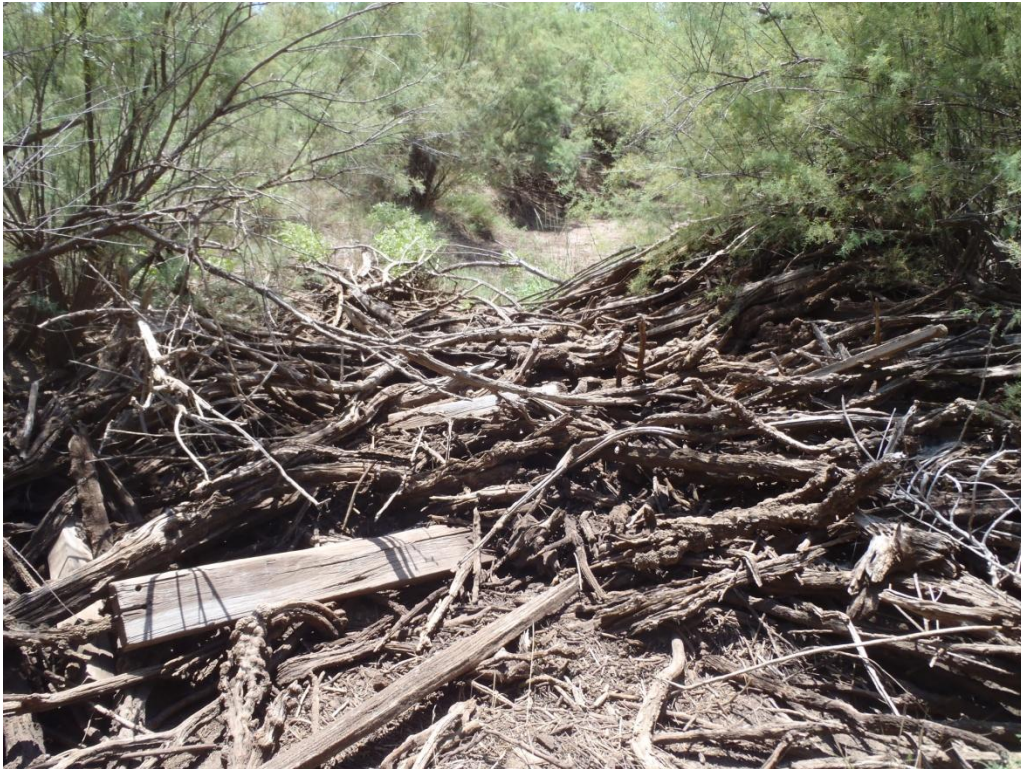
This site was surveyed June 10 and August 12, 2013. Access to this site was through a private gate only with landowner permission. Once at the site, access to the stream channel was moderately easy (Table 4.6). It lacked water, the bottom was dry and firm with gently sloping banks and a few log obstructions (Figure 4.58). Heavy vegetation added some difficulty to conducting the survey at this site.

Figure 4.58 Photograph of PD023 taken June 10, 2013 of a log obstruction.

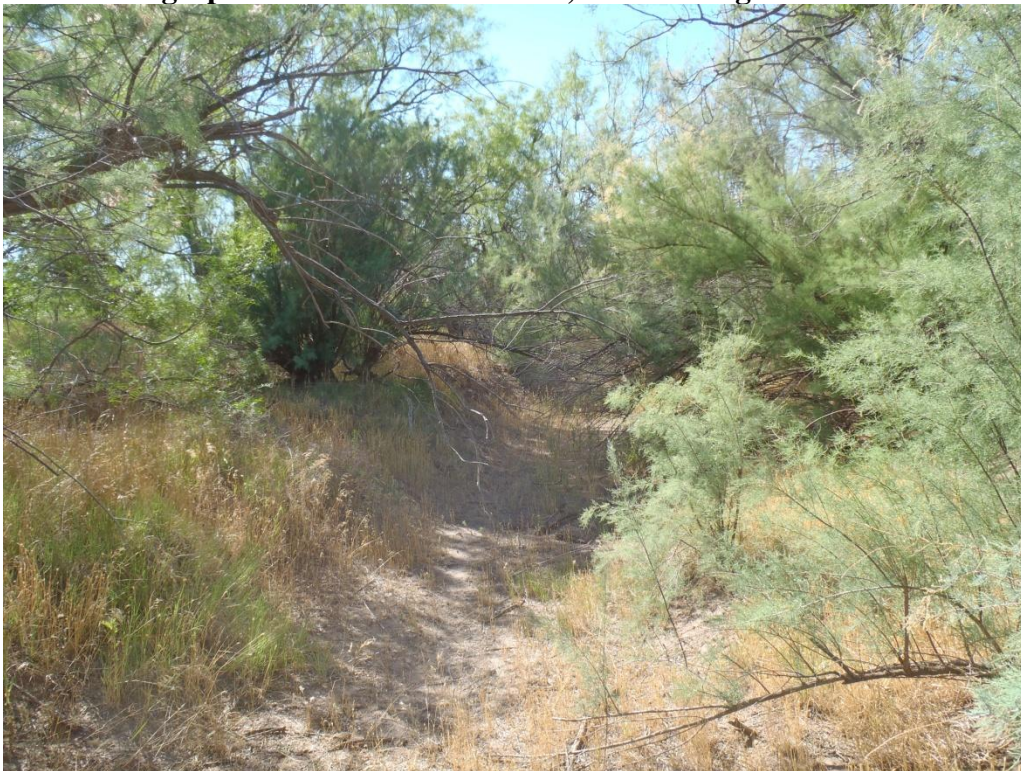
Figure 4.59 Photograph of PD023 taken August 12, 2013. Upstream view at the 150-m transect. Note shrub and grass vegetation on the banks and lack of water.

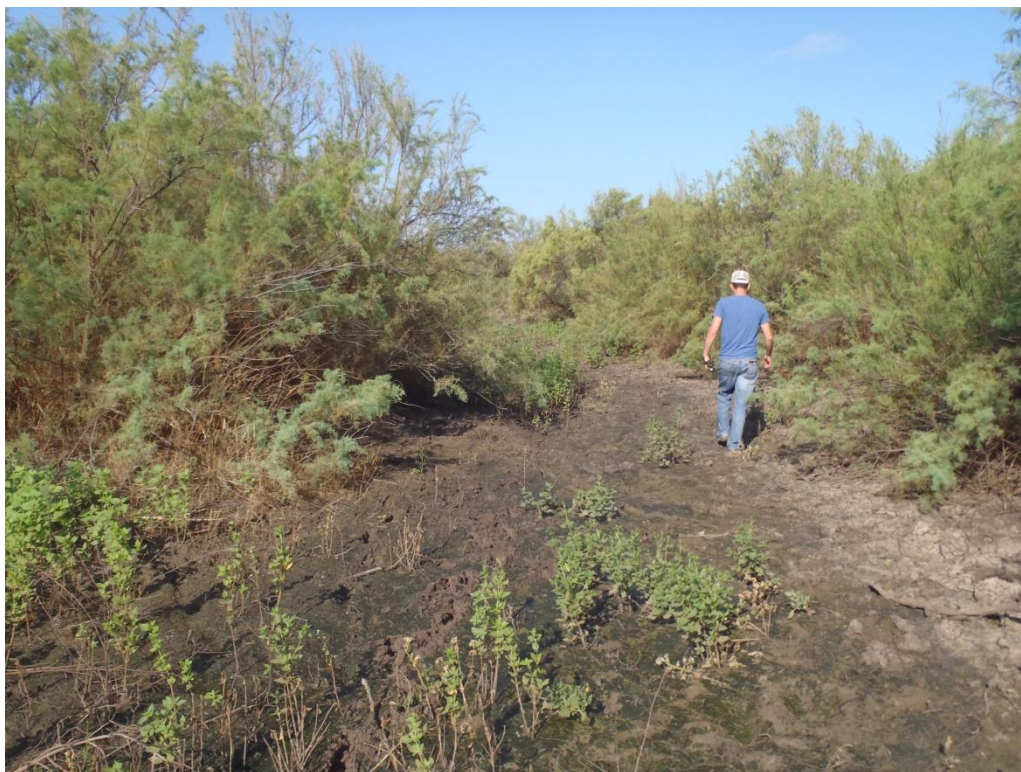
The primary substrate was a mud/clay. The corridor was primarily shrubland (Table 4.5 and Figure 4.60). Banks were gently sloping. Evidence of wildlife presence was rare, however hog tracks were observed (Tables 4.9 and 4.10). Tracks and manure of cattle were noted as well. The only garbage observed was during the first survey of a small compressed-helium tank. No evidence of human recreation was observed at this site (Figure 4.61).

Figure 4.60 Photograph of PD 024 taken August 13, 2013. Upstream view of the 150-m transect. Note lack of water and dense bank vegetation. TIAER personnel in photograph.

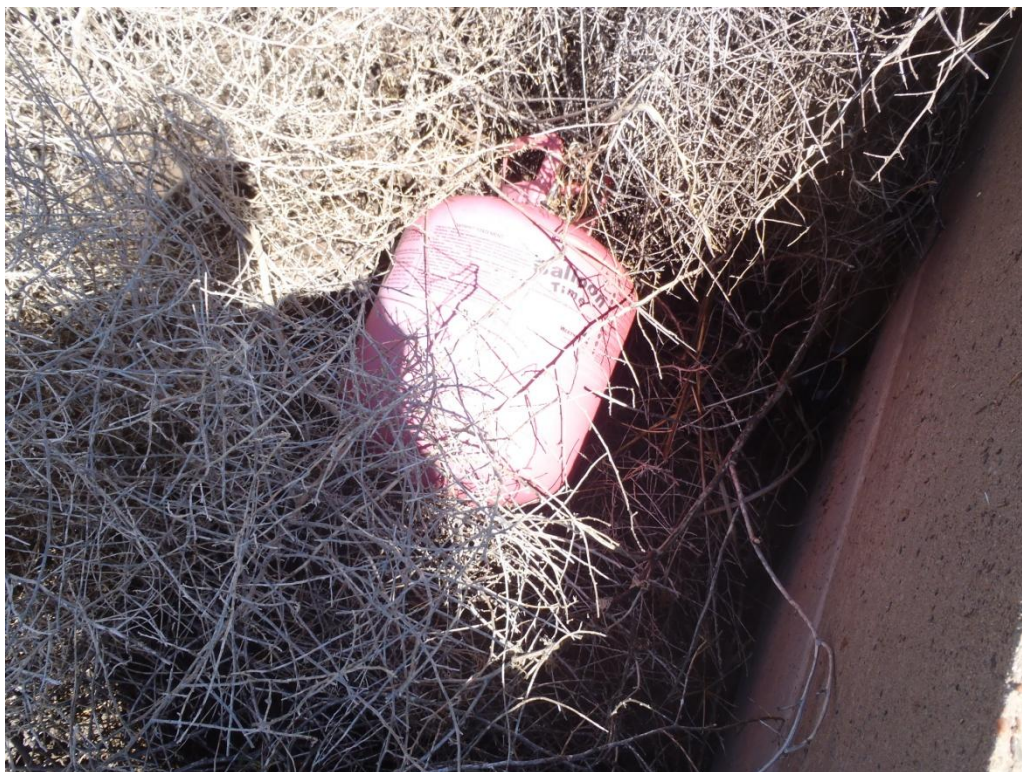
Figure 4.61 Photograph of PD024 taken June 9, 2013 of a compressed-helium tank.

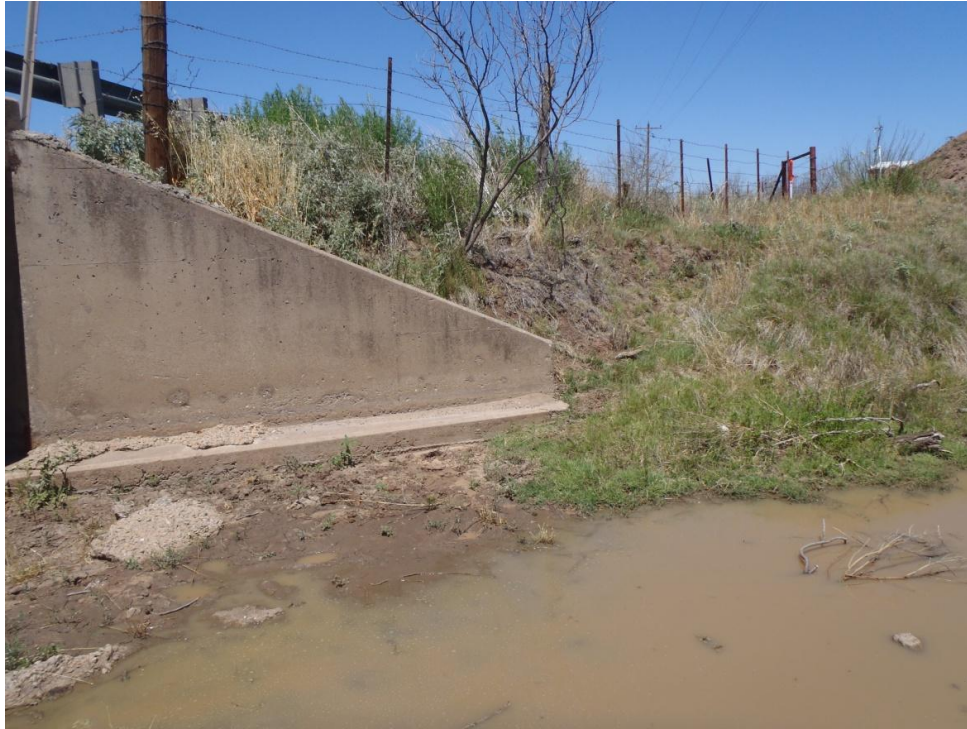
This site was surveyed June 10 and August 12, 2013. Access to the stream at this site is only possible from the bridge crossing. Private fencing was built up to the sides of the bridge (Figure 4.62), and landowner permission was required to access the site through a closed gate in order to conduct the survey (Table 4.6). Once at the site, travel through the stream was easy, except for a few pockets of water where wading through the mud was difficult.

Figure 4.62 Photograph of PD025 taken June 10, 2013. Left bank view at the 300-m transect. Note fence line built up to edge of bridge limiting public access and presence of water.

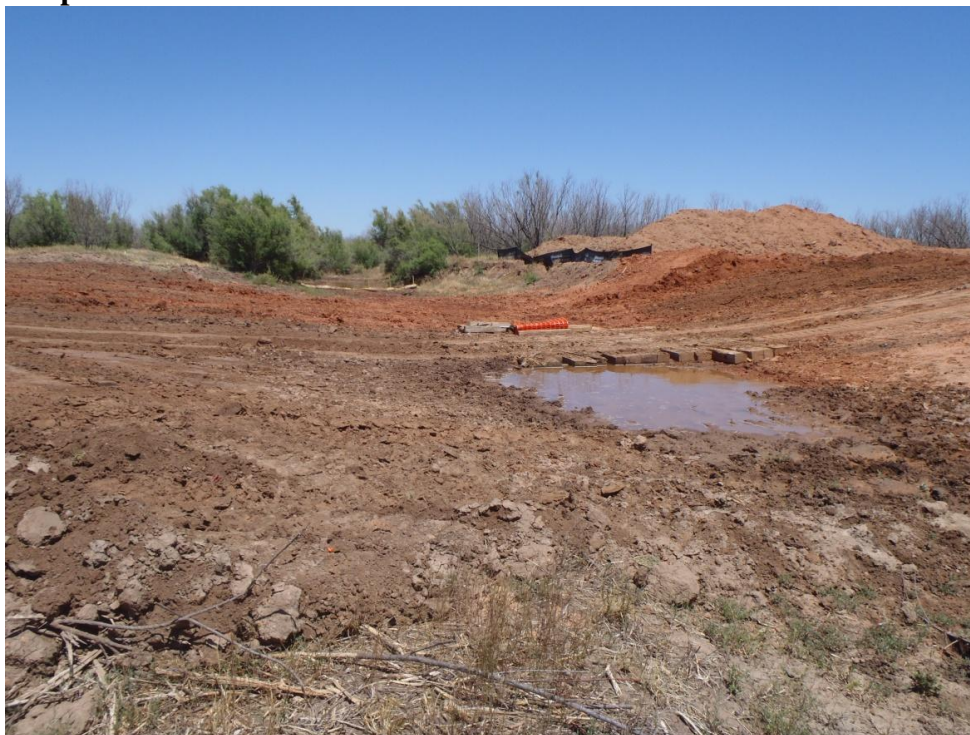
Primary substrate consisted of a clay/mud mix. The corridor at this site was dominated by shrubs on both banks. Current construction of a power line right of way bisected the creek between the 150-m and 300-m transects, which formed a break in the bank vegetation (Table 4.5). This section of the creek had been excavated to develop a low crossing across the creek for vehicles. Additionally, erosion control structures and related materials were present in the channel and along the banks within the vicinity of the construction activity (Figure 4.63). During the first survey water surfaces had foam and scum and the color of the water was green. During the second survey water surfaces had only scum and the color had become brown (Figure 4.64).

Figure 4.63 Photograph of PD025 taken June 10, 2013 of power line construction right of way crossing the stream between 300-m and 150-m transects. Note excavated earth, pocket of water and erosion control structures.

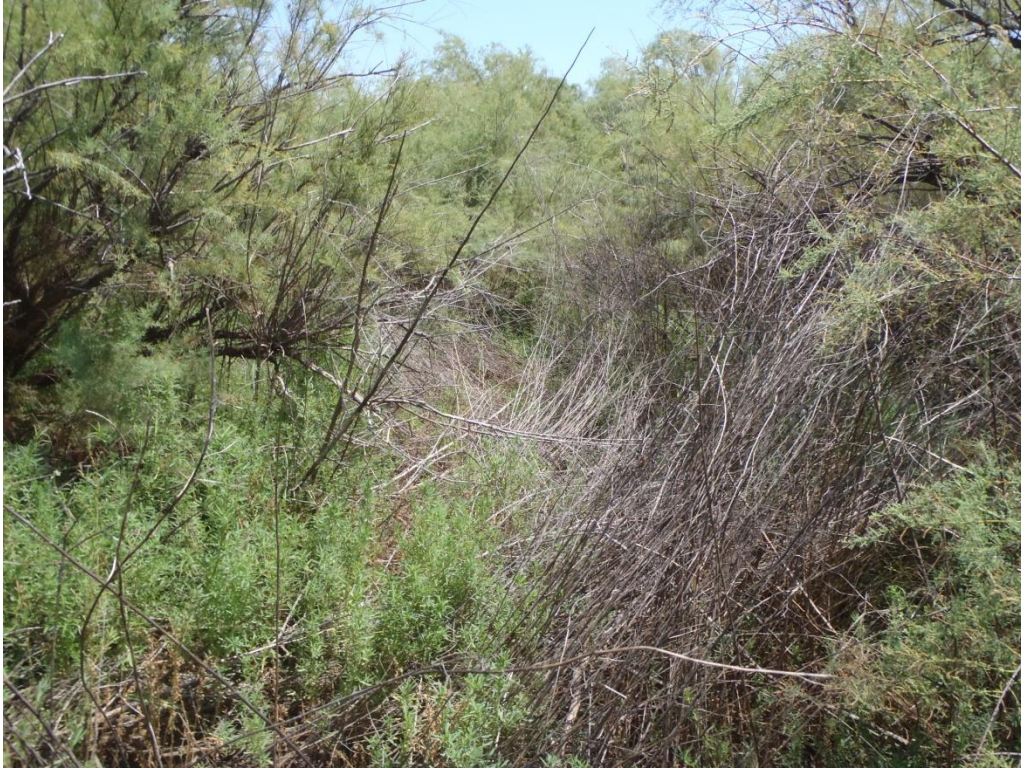
This site was surveyed June 9 and August 12, 2013. This site is publically accessible at the bridge on CR 288 and at a transmission line road. Nevertheless, landowner permission was obtained prior to conducting the surveys. Accessing this site for the survey was moderately difficult primarily because of dense vegetation (Table 4.6 and Figure 4.65).

Figure 4.65 Photograph of PD026 taken August 12, 2013. Downstream view at the 300-m transect. Note the dense vegetation.

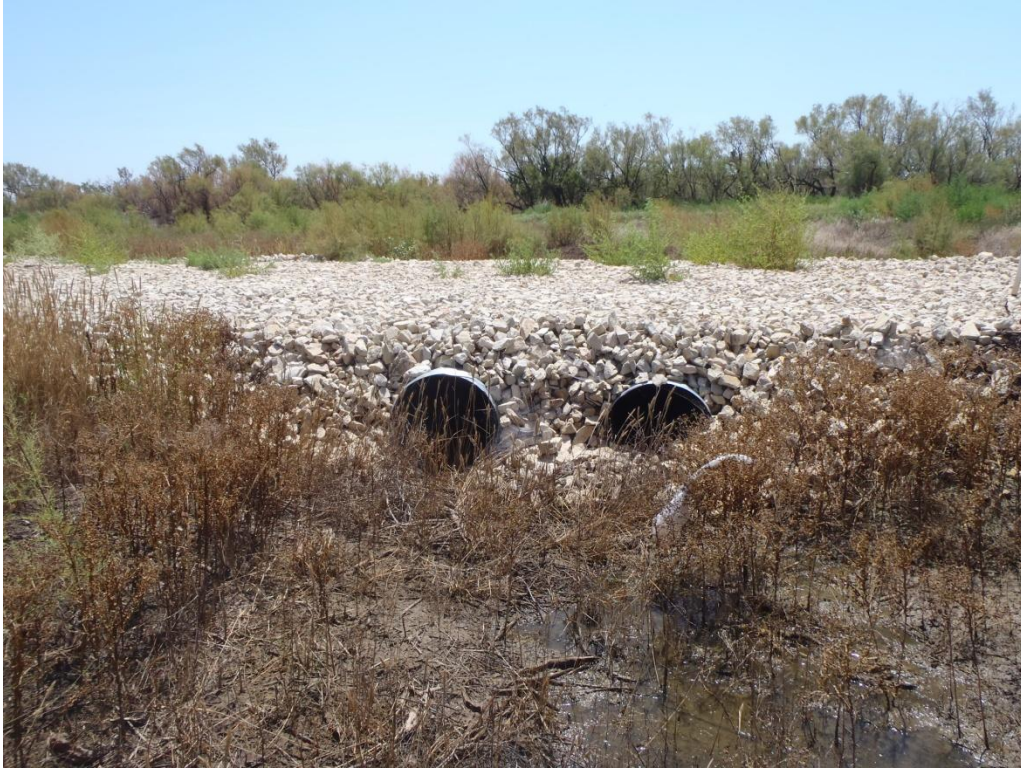
Similarly to PD025, new transmission line construction and a right of way bisected the creek between the 30m and 150m transects. However a more substantial crossing had been built including a culvert and rip-rap (Figure 4.66). A flatbed trailer loaded with transmission line components was observed near the riparian area (Figure 4.67).

Figure 4.66 Photograph of PD026 taken August 12, 2013 of the transmission line right of way located between the 30-m and 150-m transects.

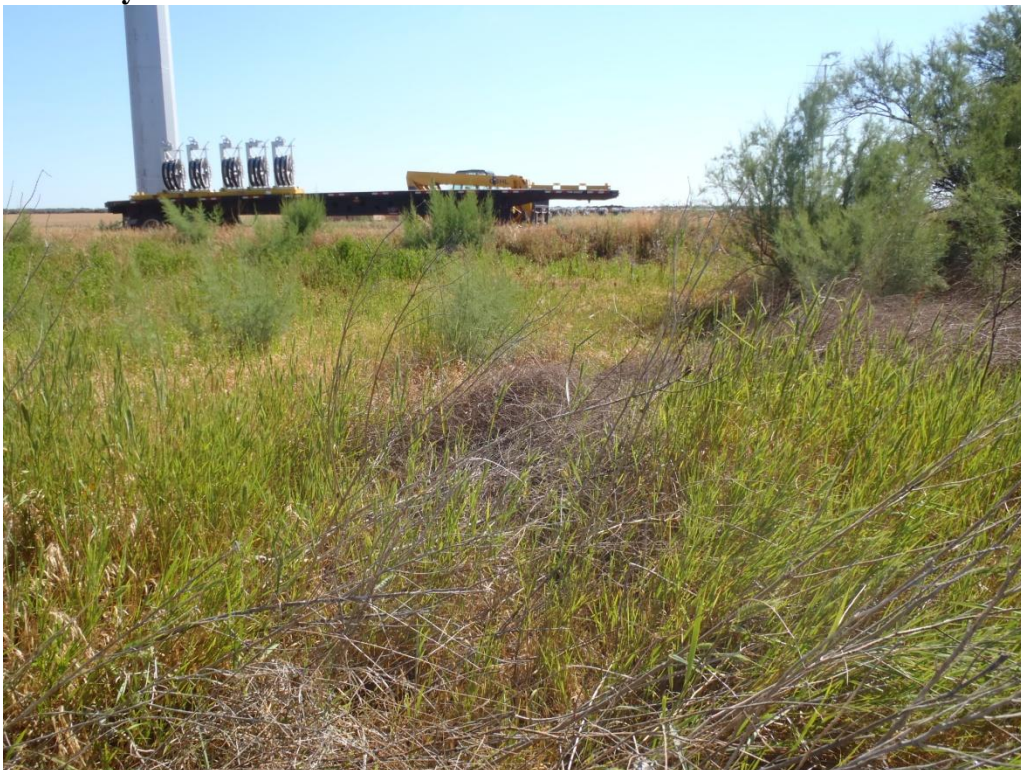
Figure 4.67 Photograph of PD026 taken June 9, 2013. Left bank view at the 30-m transect. Note the flatbed trailer loaded with transmission line components.

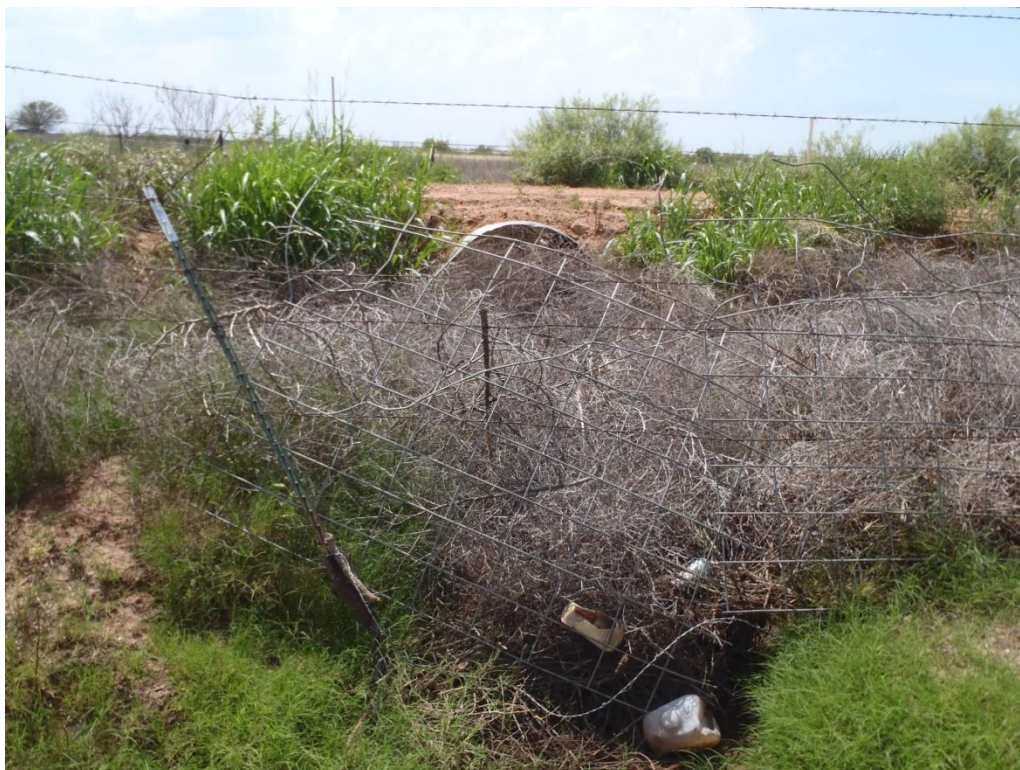
This site was surveyed June 9 and August 11, 2013. It was accessible from the county road bridge, however, landowner permission to cross a private fence was required to conduct the entire survey (Figure 4.68). Traversing the stream was easy as it had no water in it, the bottom was dry and firm with gently sloping banks and only a few log obstructions (Table 4.6).

Figure 4.68 Photograph of PD027 taken August 11, 2013. Upstream view at the 300-m transect. Note limited public access at the county road, private fence and garbage.

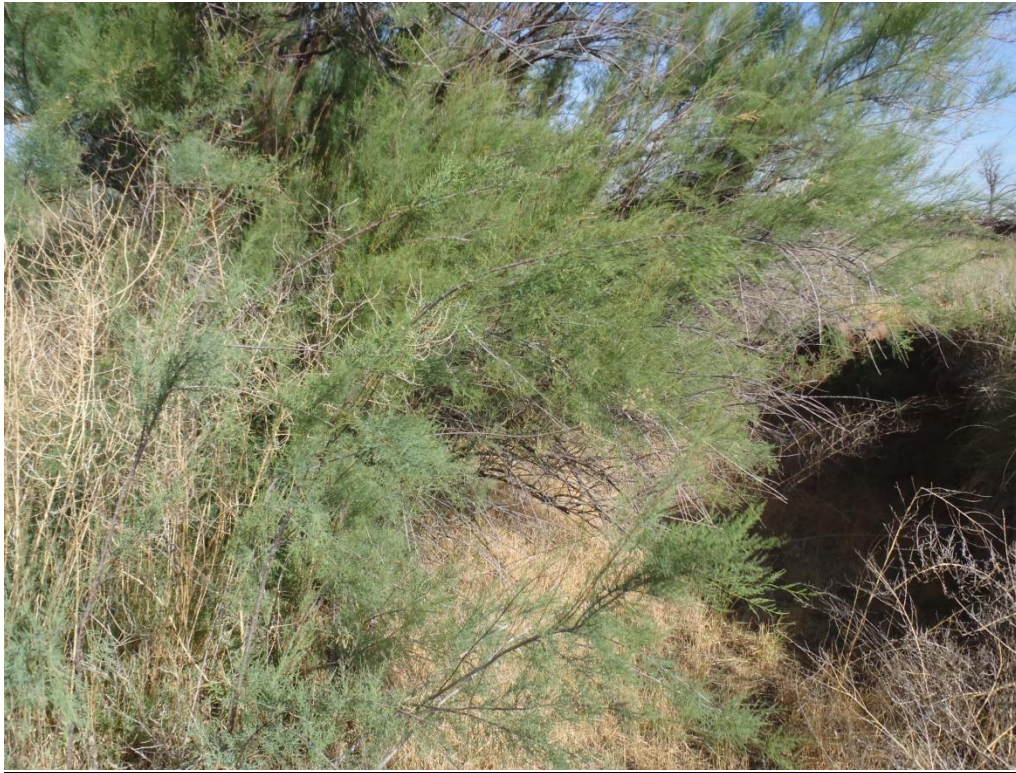
This site was surveyed June 11 and August 13, 2013. Access to this site was through a private gate only with landowner permission. Once at the site, access to the stream channel was moderately easy (Table 4.6). It lacked water, the bottom was dry and firm with gently sloping banks and a few log obstructions. Heavy vegetation added some difficulty to conducting the survey at this site (Figure 4.70).

Figure 4.70 Photograph of PD028 taken June 11, 2013. Log obstruction and dense vegetation at 200-m transect.

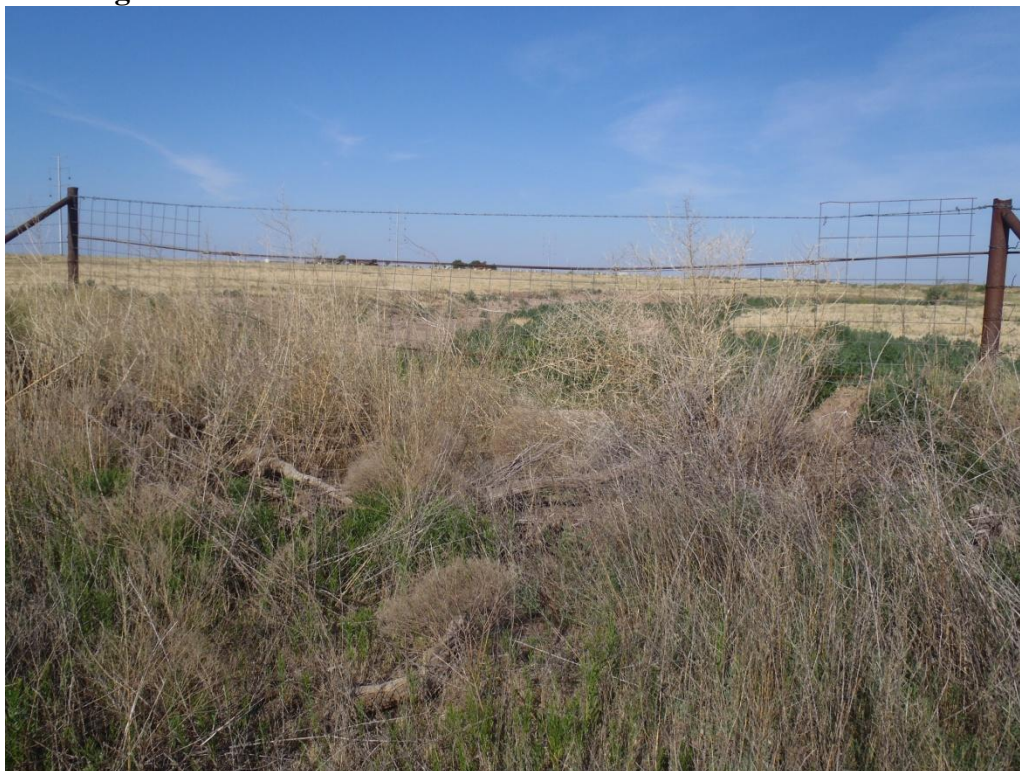
The primary substrate was a mud/clay but the creek was dry therefore mud was not encountered. The area immediately at the edge of the creek has some shrubby vegetation but is primarily native pasture up to the edge of the creek (Table 4.5 and Figure 4.71).

Figure 4.71 Photograph of PD028 on June 11, 2013. Upstream view of the 300-m transect. Note private fence bisecting the creek and pasture dominated corridor.

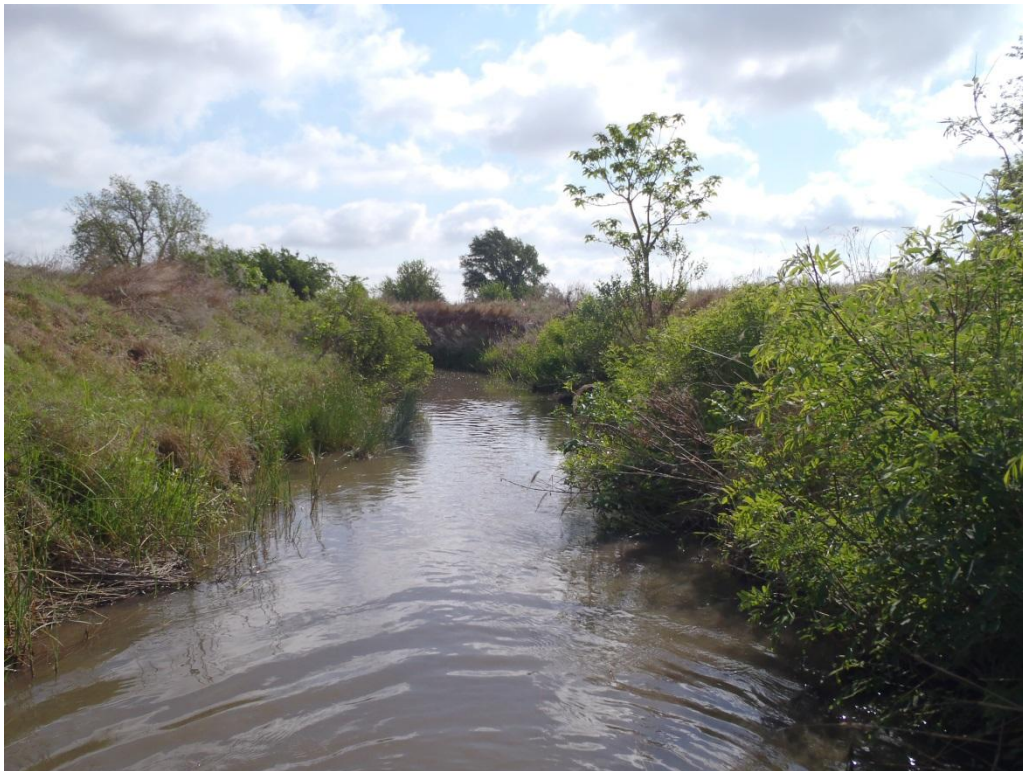
Figure 5.3 Photograph of Sweetwater Creek Site SW001 taken on May 26, 2013. The downstream view of the 300-m transect.

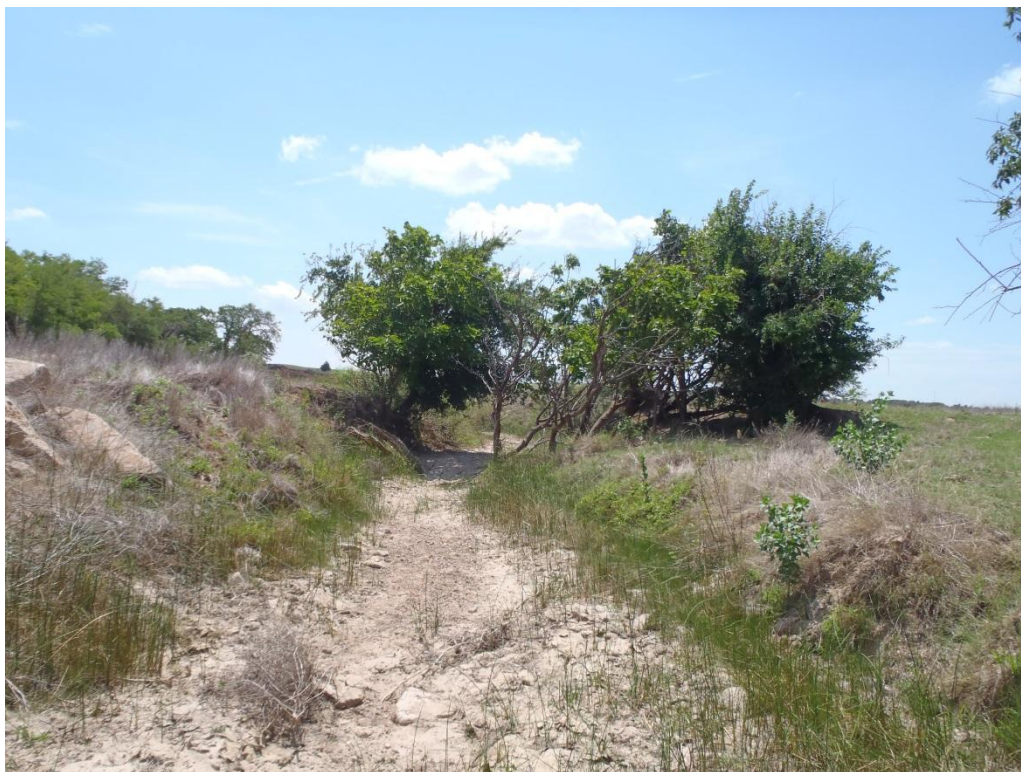
Figure 5.4 Photograph of Sweetwater Creek Site SW001 taken on July 29, 2013. The upstream view of the 300-m transect.

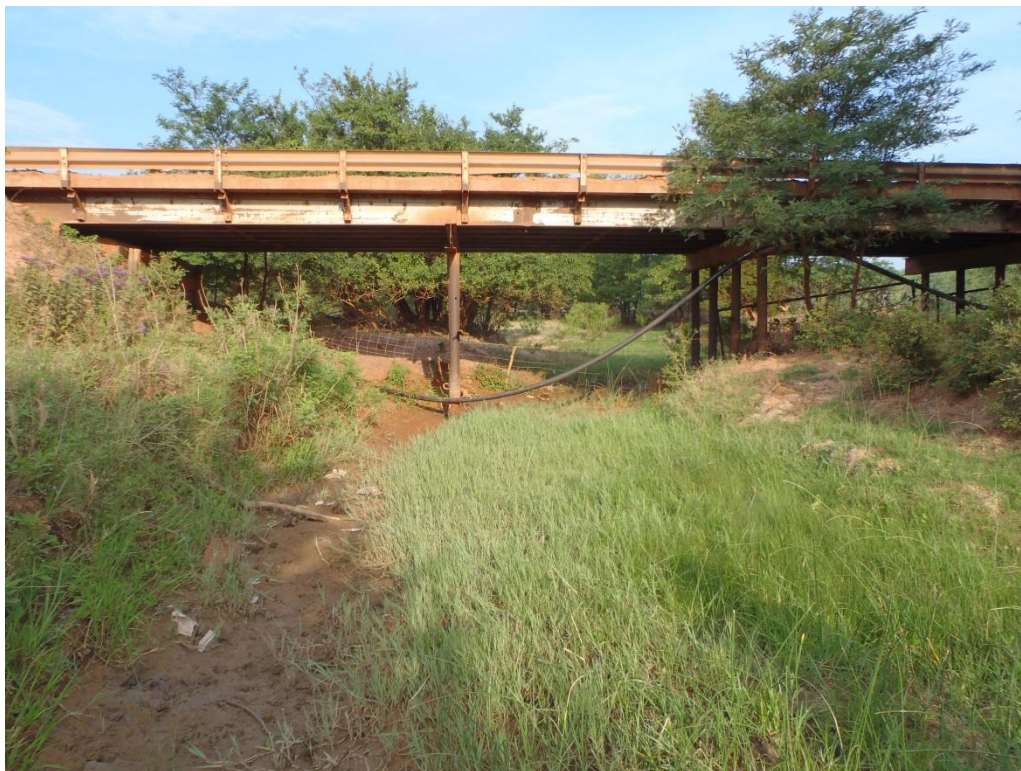
Sweetwater Creek at site SW002 was visited on May 26 and July 29, 2013. This site, located east of Wheeler, Texas in Wheeler County, was accessible through private lands that were fenced with a cattle guard and potentially locked gate. Although the site is listed as being publically accessible, access is very limited due to the property fences attaching to the bridge (Figure 5.5). With

Figure 5.5 Photograph of Sweetwater Creek Site SW002 taken on July 29, 2013. The upstream view of the 150-m transect.

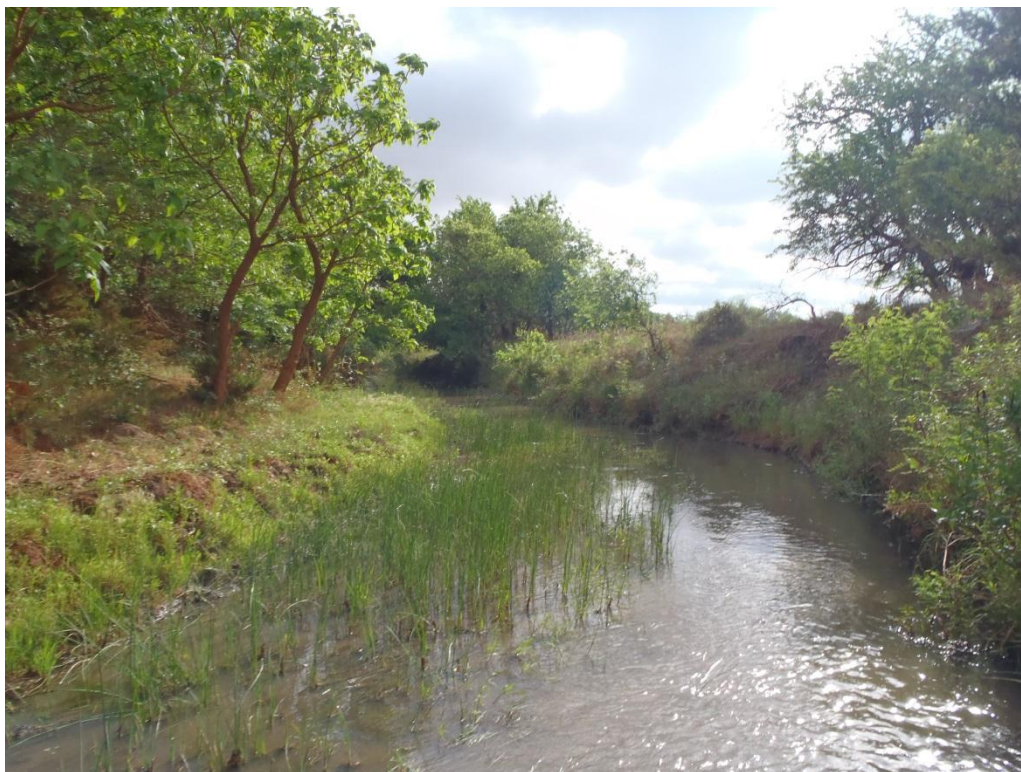
Figure 5.6 Photograph of Sweetwater Creek Site SW002 taken on May 26, 2013. The downstream view of the 150-m transect.

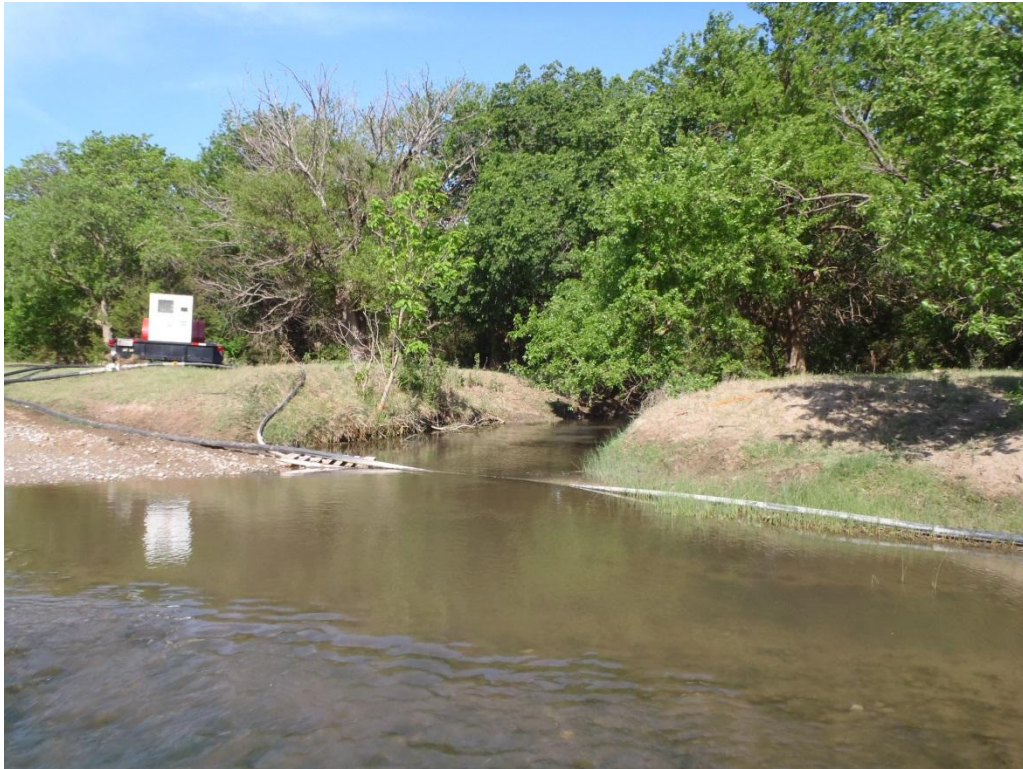
Figure 5.7 Photograph of Sweetwater Creek Site SW003 taken on May 26, 2013, the upstream view of the 150-m transect.

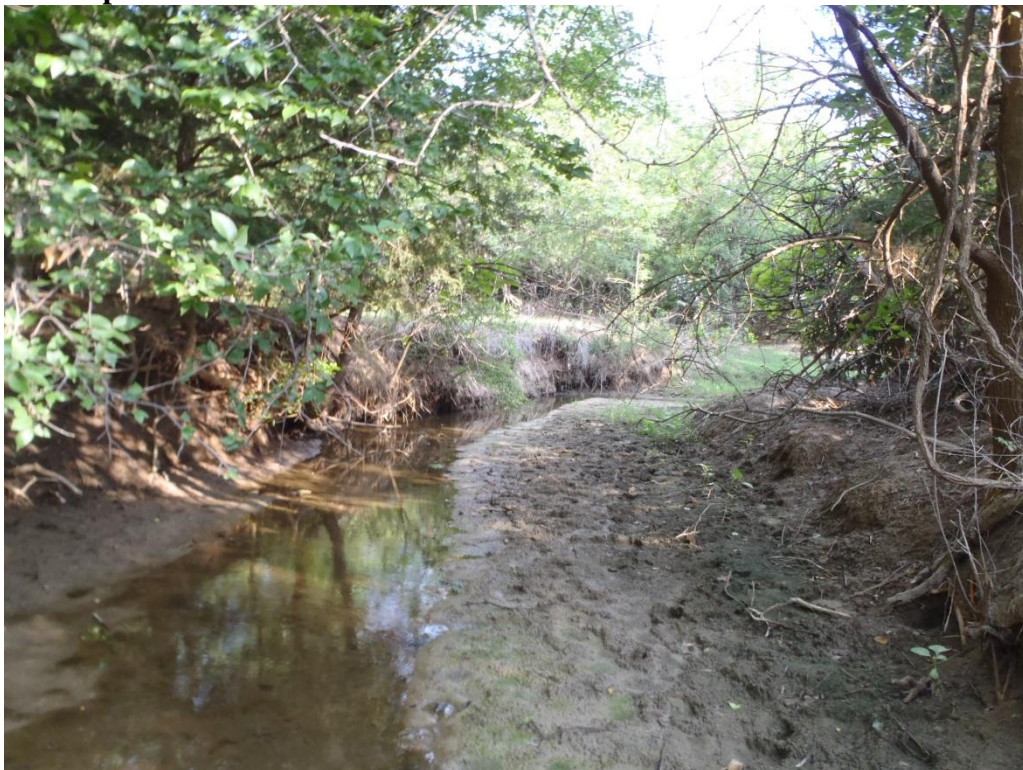
Figure 5.8 Photograph of Sweetwater Creek Site SW003 taken on July 29, 2013, the upstream view of the 300-m transect.

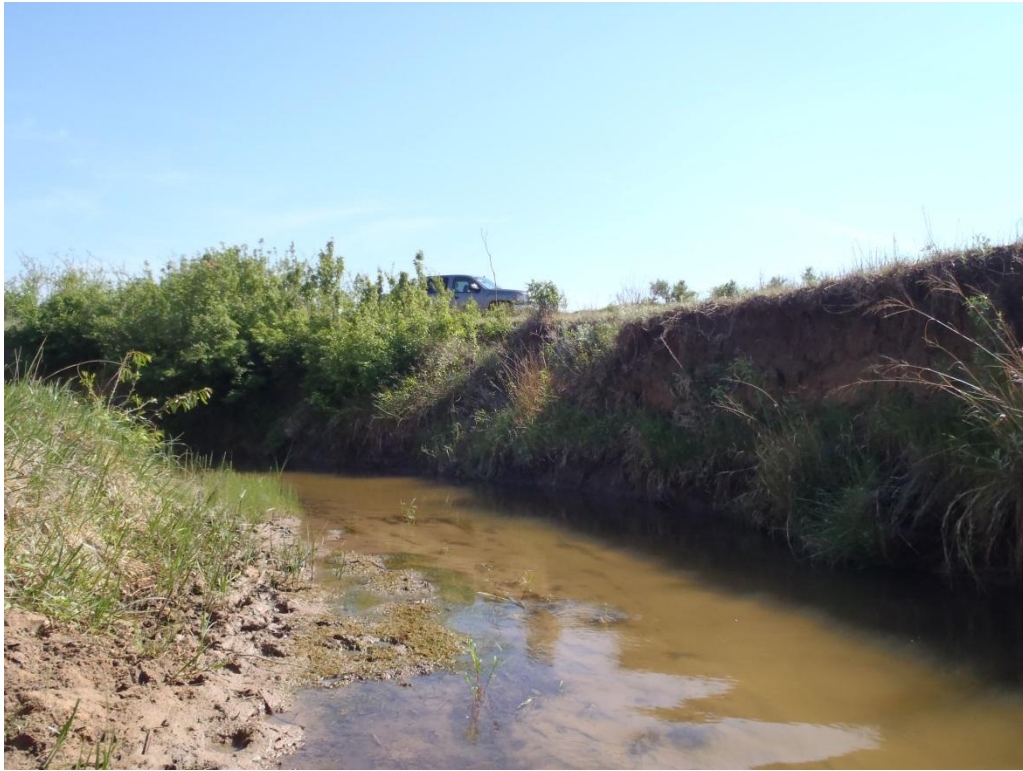
Figure 5.9 Photograph of Sweetwater Creek Site SW004 taken on May 26, 2013, the upstream view of the 30-m transect. TIAER vehicle shown in the background.

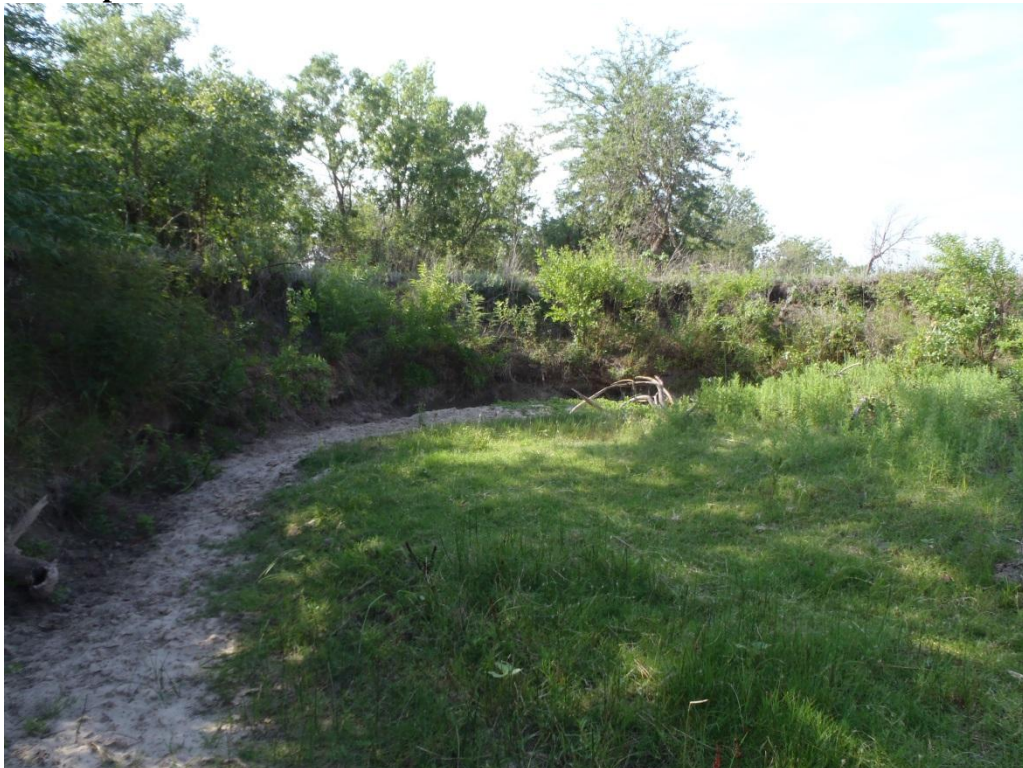
Figure 5.10 Photograph of Sweetwater Creek Site SW004 taken on July 29, 2013, the upstream view of the 300-m transect.

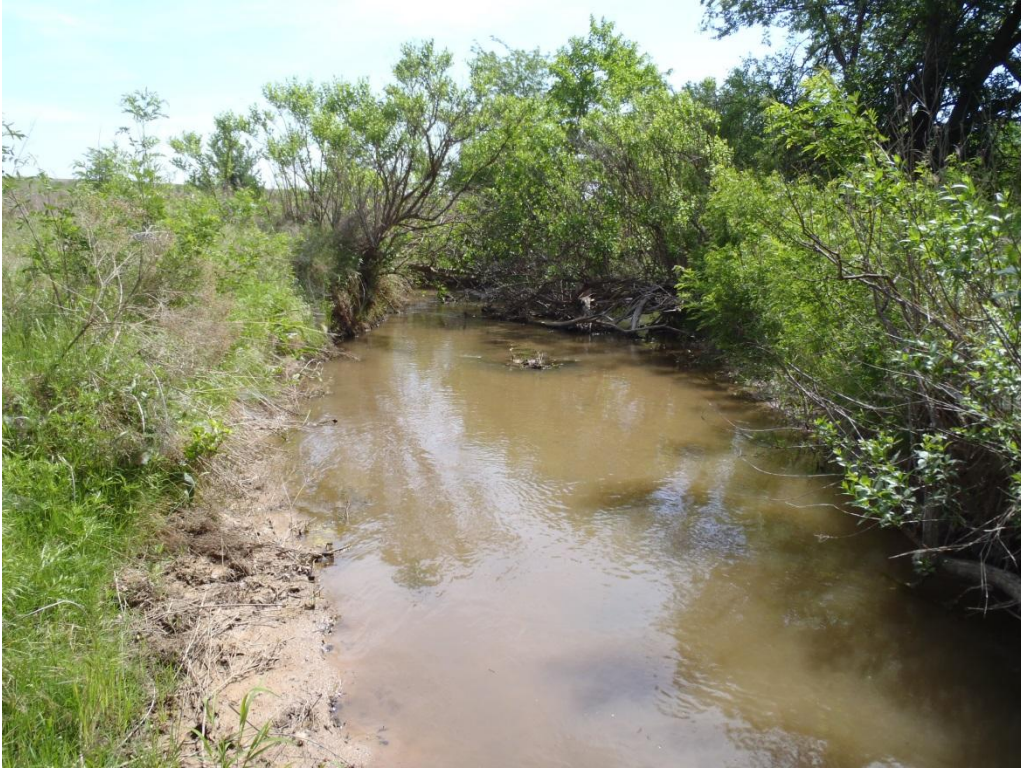
Figure 5.11 Photograph of Sweetwater Creek Site SW005 taken on May 26, 2013, the downstream view of the 300-m transect.

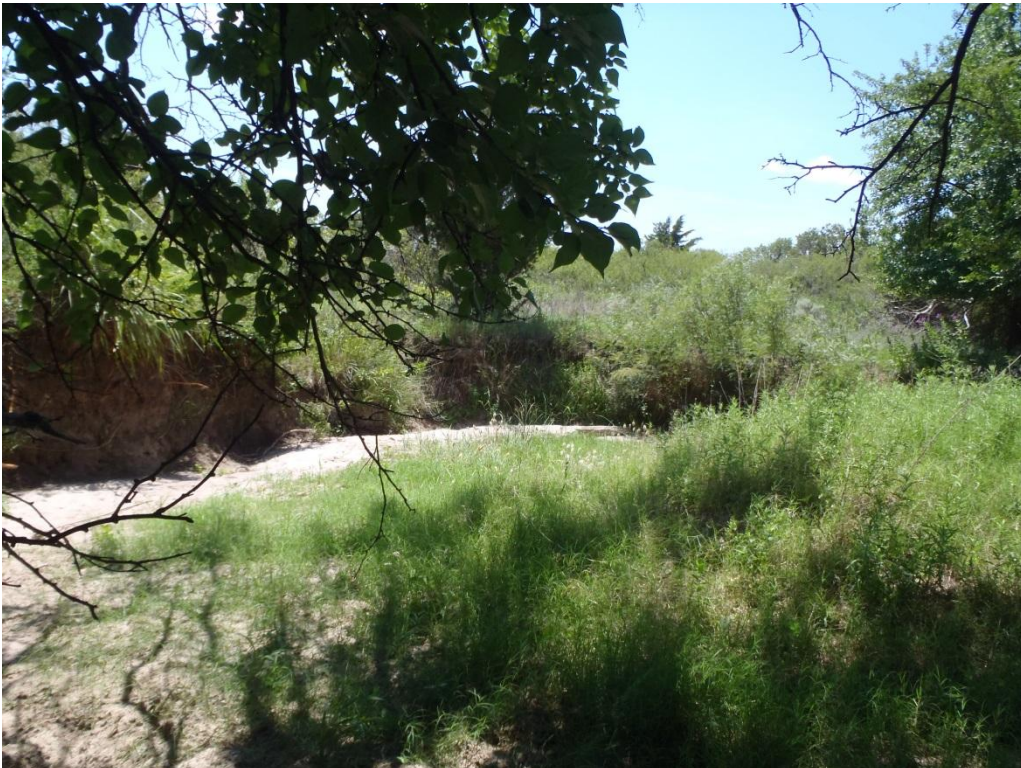
Figure 5.12 Photograph of Sweetwater Creek Site SW005 taken on July 29, 2013, the upstream view of the 150-m transect.

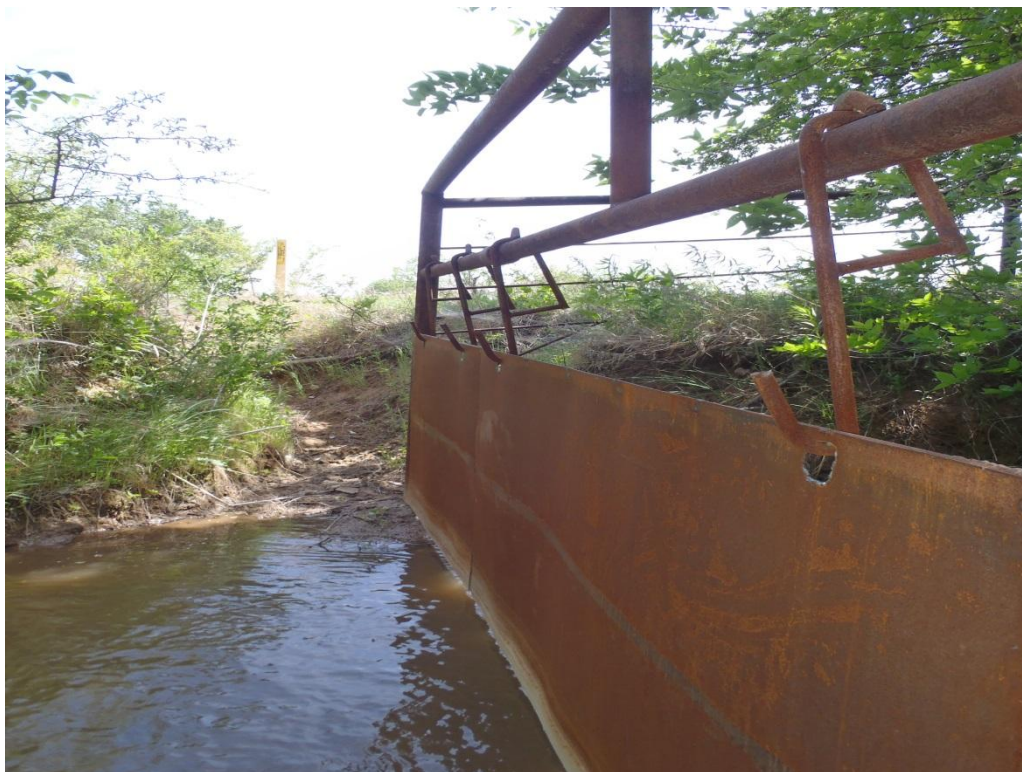
Site SW005 was wadeable for the entire 300-m reach length. Average thalweg ranged from 0.31 m during the first survey to 0.0 m during the second survey when the stream was dry (Table 5.6). During both surveys, the shallow water depths or lack of water with the sandy substrate made wading in the stream channel easy. Widths of the stream ranged from 2.5 m to 10 m during the first survey when water was present (Tables 5.7 and 5.8). There were a couple of log obstructions and one metal water gap located in the lower half of the reach (Figure 5.13).

Figure 5.13 Photograph of Sweetwater Creek Site SW005 taken on May 26, 2013, the water gap obstruction.
